Landscape and Urban Planning 42 (1998) 1–14

A geomorphological design for the rehabilitation of an abandoned sand quarry in central Spain

J.F. Martín Duque^{a,*}, J. Pedraza^a, A. Díez^b, M.A. Sanz^a, R.M. Carrasco^b

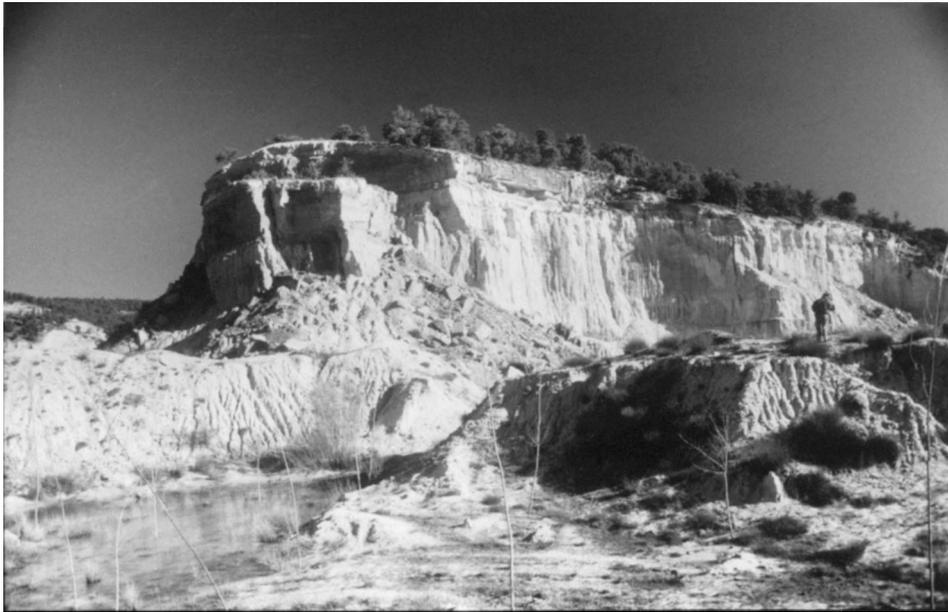
Fig. 2. General view of the west sector of the quarry prior to the rehabilitation: dispersed spoils banks affected by erosion processes, falling of blocks from the abandoned quarry face and significant impact on the ecology and landscape.

(landslides, falls) on the old quarry face (see Fig. 2).

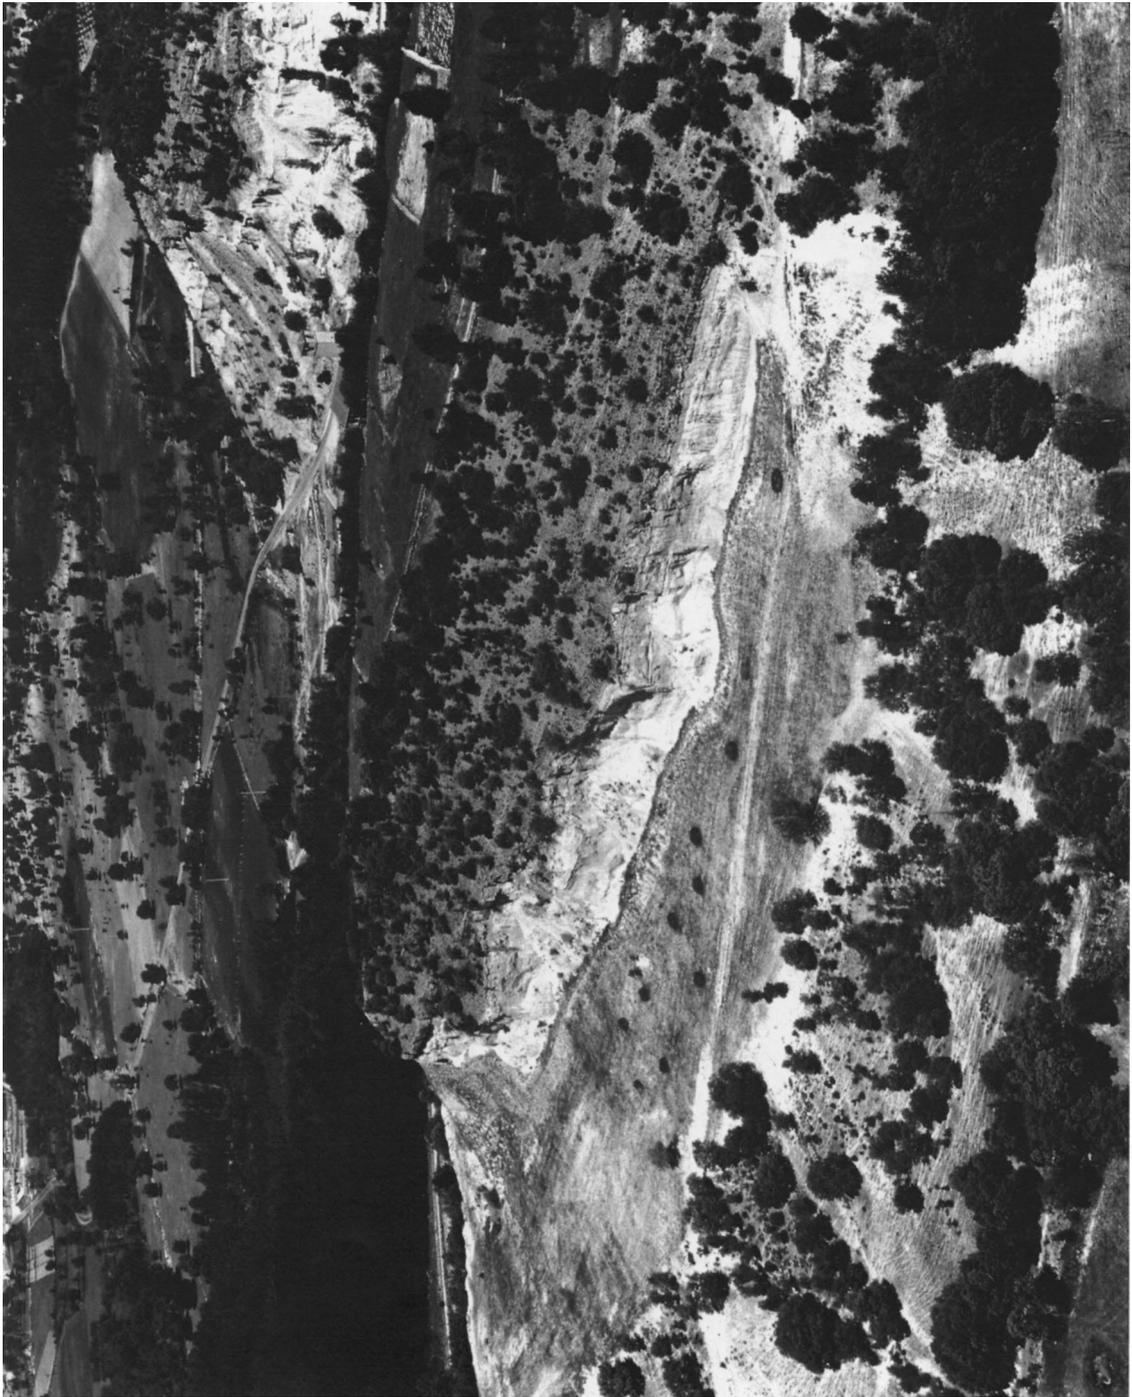
Fig. 8. Aerial view of the rehabilitated surface (May 1996). Photo: Paisajes Españoles S.A.

3. Subsequent to the rehabilitation activities, the appearance of the area is shown in Fig. 8. This situation is considered to be provisional, since, in time the terrain will acquire a dynamic equilibrium profile based on the evolution of the scarp (see Fig. 7(D)). At the same time, a vegetation colonization will occur which will eventually lead to the restoration of a wood with similar features to those of the surrounding area. The average time estimated for completion of this process is around 50 years; this assumption is based on a study of the behaviour of the adjacent slopes.

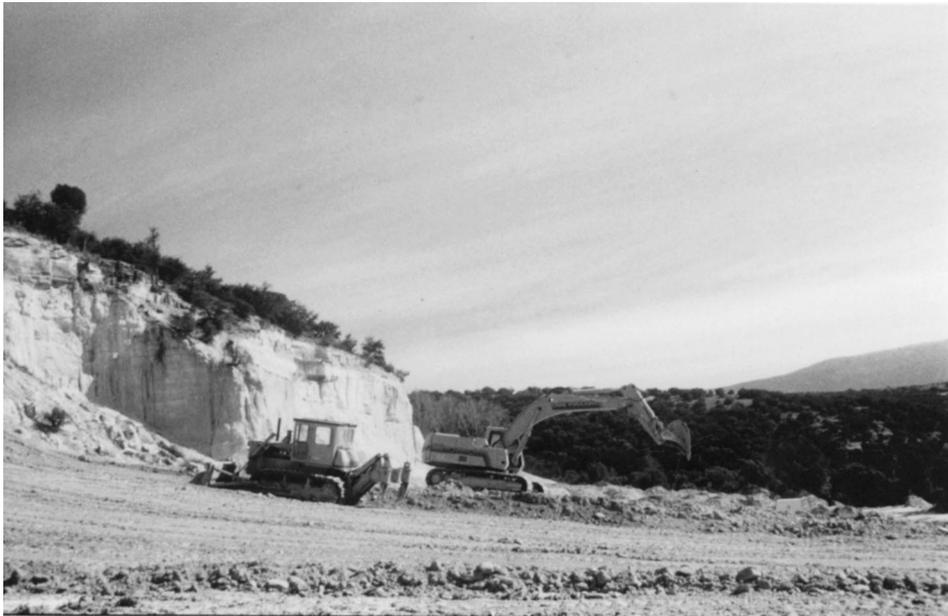
Fig. 9. The project was performed between January and February 1995. The picture shows the works relating to reconstruction of the glacial type morphology, and extending of the colluvial material on the final surface. Since the use of heavy machinery led to compactation of the terrain, decompaction work was subsequently carried out using the traditional farming techniques of the region (ripping, ploughing).

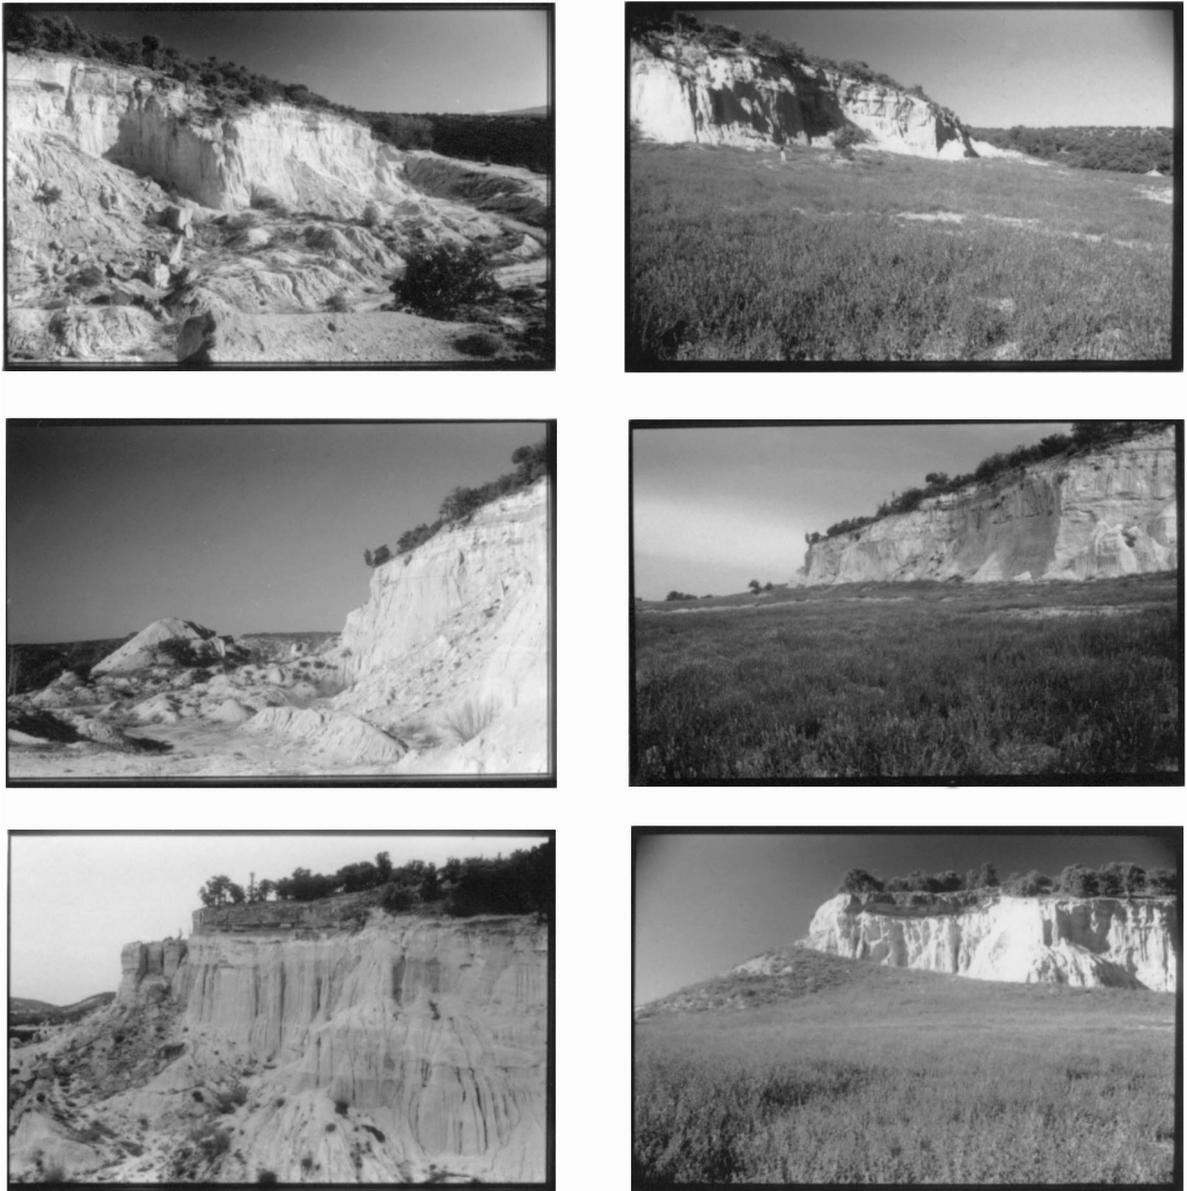
Fig. 10. Different details of the rehabilitated surface (May 1997) and comparison with the situation prior to restoration. The conditions established have enabled a satisfactory development of the vegetation cover at the slope base.

surface vegetation has been satisfactory, since practically, all the seeded area has been covered by vegetation (Fig. 10); vegetation growth has been slow in those areas, in which it was not possible to recover with the colluvial material, consequently, causing the soil to develop on a sand substratum (only *Lolium rigidum* adapts to this type of substratum, and only in
