## Geomorphic reclamation for reestablishment of landform stability at a watershed scale in mined sites: The Alto Tajo Natural Park, Spain

### ABSTRACT

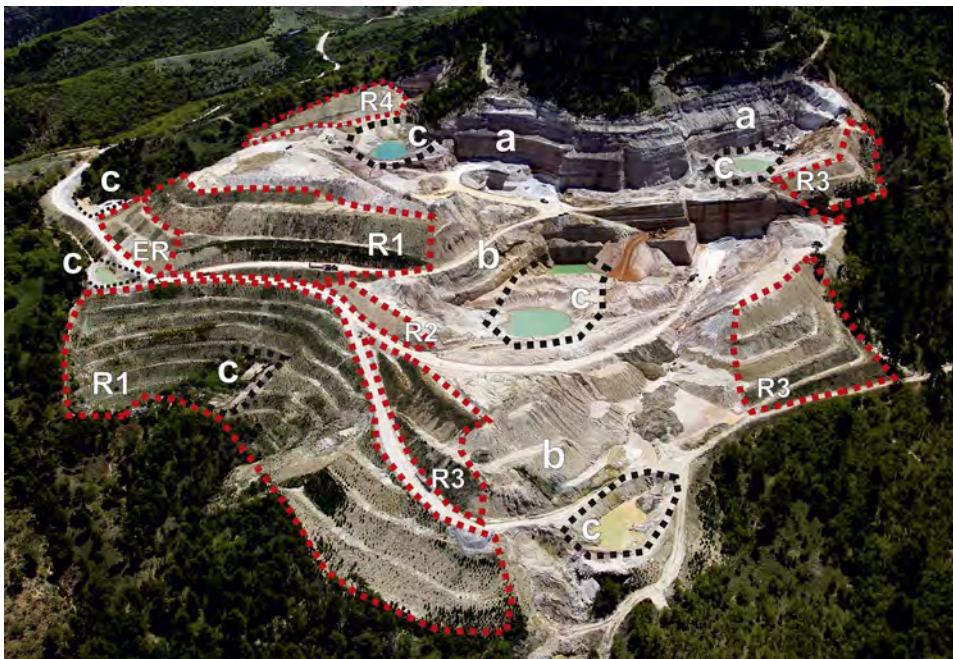
Fig. 4. Oblique aerial view of the El Machorro mine in 2014. Photo by Paisajes Españoles (2014). a, open pit; b, un-reclaimed waste dumps; c, ponds; R1, terraces covered with carbonate colluvium; R2, smoothed sloping terraces covered with carbonate colluvium; R3, terraces covered both with carbonate colluvium and soils; R4, geomorphic reclamation using GeoFluv-Natural Regrade (site of this study); ER = experimental mining reclamation waste dump.

As an active mine, a large part of its surface is either dynamic open pit (Fig. 4a) or waste dumps (Fig. 4b). A system of ponds (Fig. 4c) control the runoff and sediments yielded by these active areas. Both runoff and sediment mostly derive from un-reclaimed waste dumps, which are subject to high runoff and active rilling and gullying (Fig. 5). The areas which are not active open pit or waste dumps have been reclaimed, displaying four different approaches of landform mining reclamation, from traditional to geomorphic (Fig. 4): (R1) terraces (linear outslopes – bench and down-drain systems) covered with carbonate colluvium, (R2) smoothed sloping terraces covered with carbonate colluvium, (R3) terraces covered both with carbonate colluvium and soils, and (R4) geomorphic reclamation using GeoFluv-Natural Regrade (this study site). R1 has hydro-seeding and planted trees (mostly pines), whereas R2 and R3 have manual seeding and planted shrubs and trees.

GeoFluv – Natural Regrade allowed designing these complex landforms (R4 at Fig. 4), with a drainage network having functional channels ‘stitched’ with convex – concave slopes. The channels of this reclamation project have their headwaters at the toe of the steep highwall descending from the mesa top, from which a small amount of runoff can enter them. The channel dimensions are sized to accommodate that discharge at the headwaters and to increase in the downstream direction to add the additional discharge entering along their reclaimed valley slopes. The two reclaimed channels are classified as Strahler’s first-order streams. The dimensions and 3D shapes of the valley slopes draining to these channels are critical components of this geomorphic design method and we refer to these two small designed catchments within the greater watershed as sub-watersheds.

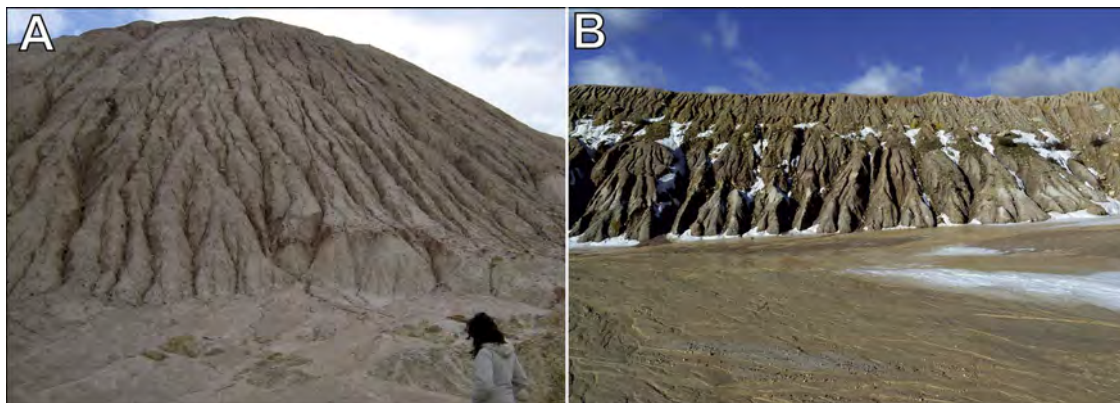
Fig. 5. Erosive-sedimentary landforms of non-reclaimed waste dumps inside the El Machorro mine. A) Rills and associated sand cones. B) Gullies and sand sheets with miniature braided landforms. All the sediments transported from these areas are captured in sediment control ponds (letter c in Fig. 4).

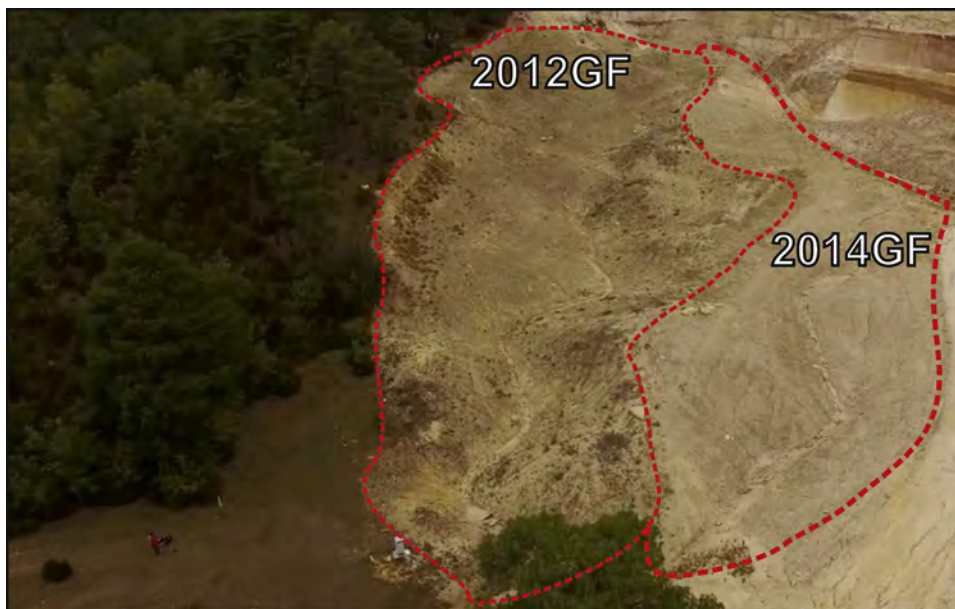
Fig. 6. Oblique aerial view of the El Machorro geomorphic reclamation site. 2012GF was constructed in September 2012 and 2014GF in September 2014. Photo by DGDRONE (2015).

Fig. 6 shows the two first-order sub-watersheds that were geomorphically reclaimed in two phases using GeoFluv-Natural Regrade, subsequently monitored: in 2012 (2012GF, 0.65 ha) and in 2014 (2014GF, 0.41 ha).

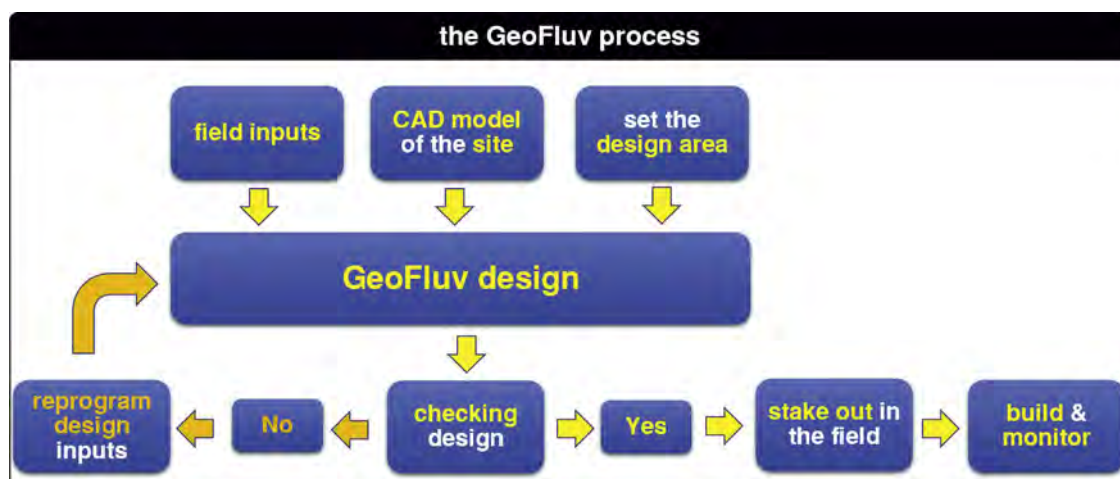
Fig. 7. Diagram showing a GeoFluv procedure. Redrawn from Landforma (2016).

A GeoFluv-Natural Regrade geomorphic reclamation process includes the following steps: (i) locating stable natural landforms in earth materials similar to those to be reclaimed, within similar environmental conditions of the project area (climate, soils and vegetation), and then measuring their characteristic features (field inputs), (ii) getting a CAD model of the site and setting the design area and its topographic constraints, (iii) making a geomorphic reclamation design following GeoFluv – Natural Regrade and reviewing the design to ensure that it meets the target design criteria and provides correct performance, (iv) exporting the topographic information to guide construction by machine control or for staking-out, (v) building the designed landforms (completed with soils replacement and revegetation), and (vi) monitoring the hydrological and erosive-sedimentary response (Fig. 7).

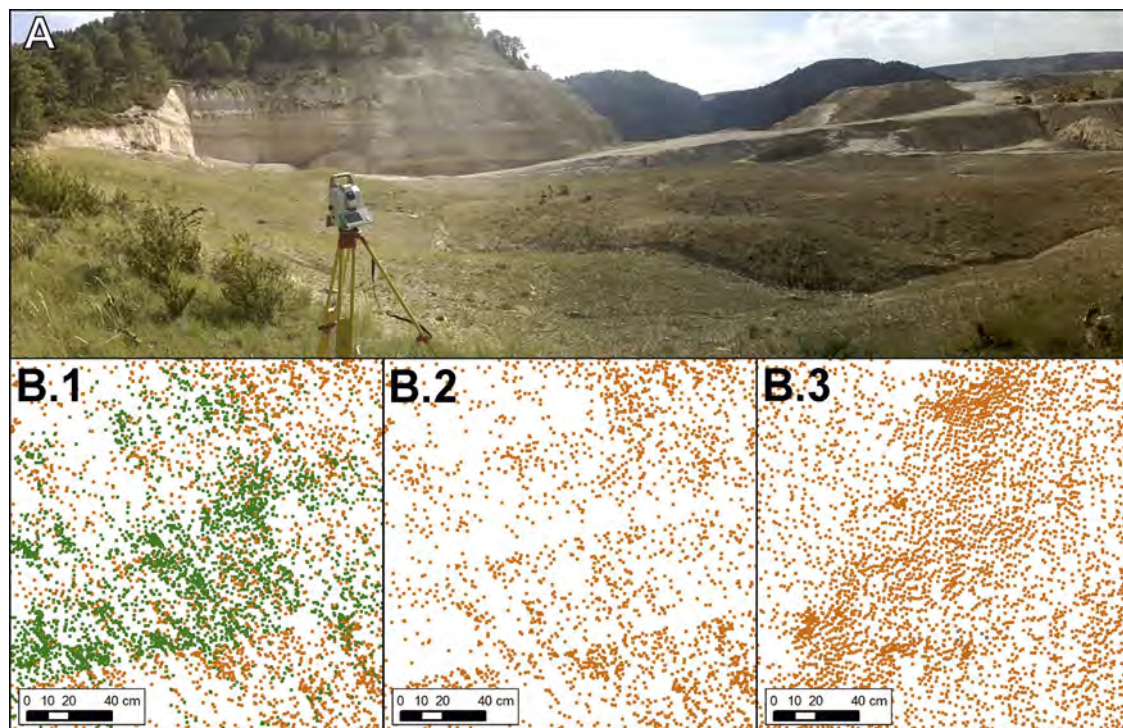
**Fig. 9.** A) View of the scanned area in July 2016 showing vegetation cover. B) Details of the 'vegetation effect' for topographic comparison. B.1 shows the 2D point cloud of the reclaimed area in July 2016, with all the scanned points (vegetation-green; ground-orange). B.2 shows the situation as of July 2016 only with ground points (after 'cleaning' the vegetation). B.3 shows the situation in April 2015 with all scanned points and the absence of vegetation.

The reclaimed surface had a significantly higher vegetation cover for the July 2016 topographical scanning than in April 2015 (see Fig. 9). Therefore, those areas of the point clouds with vegetation clumps were ‘cleaned’, producing a surface entity with polygons without points (see Fig. 9B.1 and 9-B.2). The cleaned point cloud for July 2016 (Fig. 9B.2) had a lower data density than that of April 2015 (Fig. 9B.3), even though they were surveyed following the same procedure. The reason is that vegetation acted as a ‘screen’ for the scanning process, making a shadow effect for the point gathering. Hence, we decided to remove those areas with dense vegetation from the analysis, as others have done (e.g., Smith and Vericat, 2015). Using this

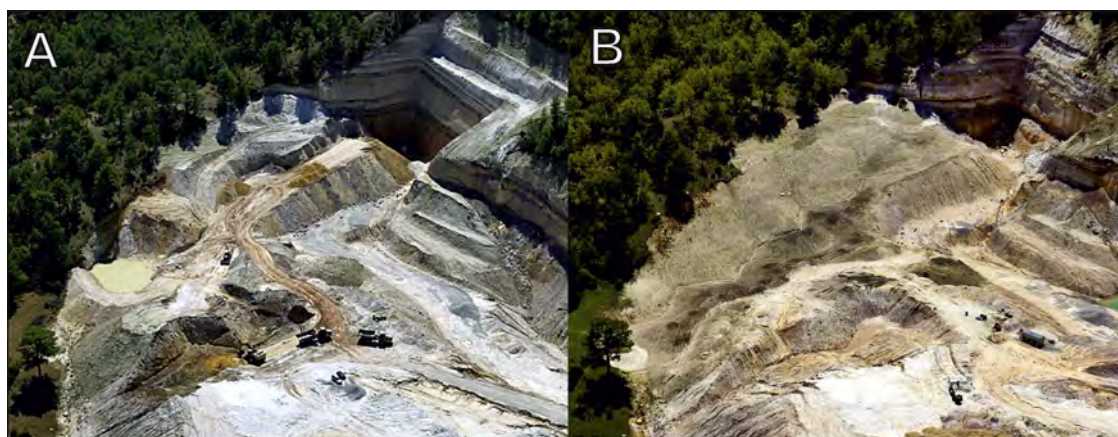
Fig. 13. Oblique aerial photos of the 2012GF area. A) At the beginning of the geomorphic reclamation, September 2012. B) The site in May 2014. Photos by Paisajes Españoles.

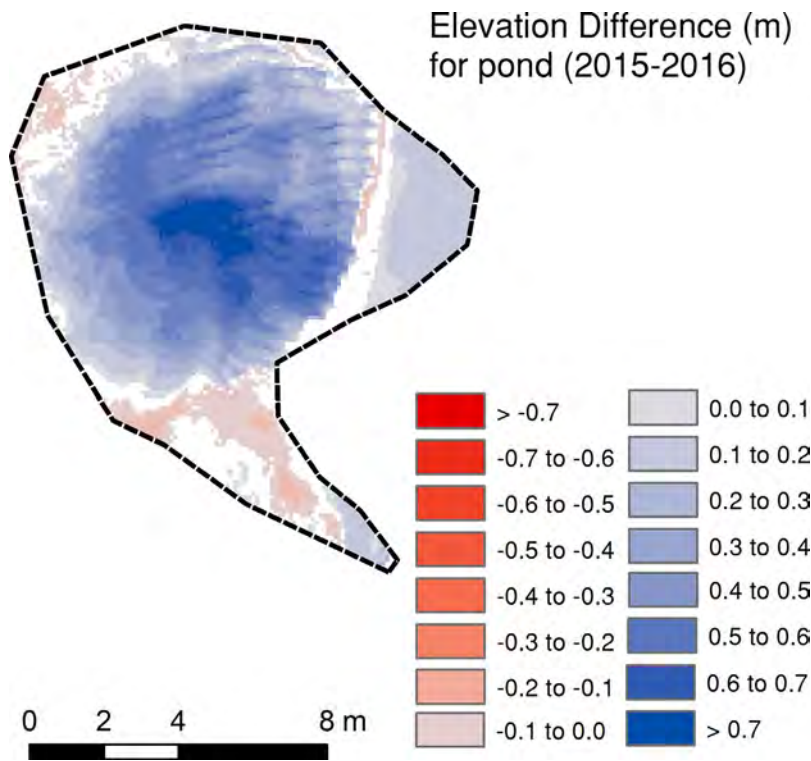
Fig. 15. DoD for the pond located at the outlet of the geomorphic reclamation of El Machorro, for the period April 2015 – July 2016.

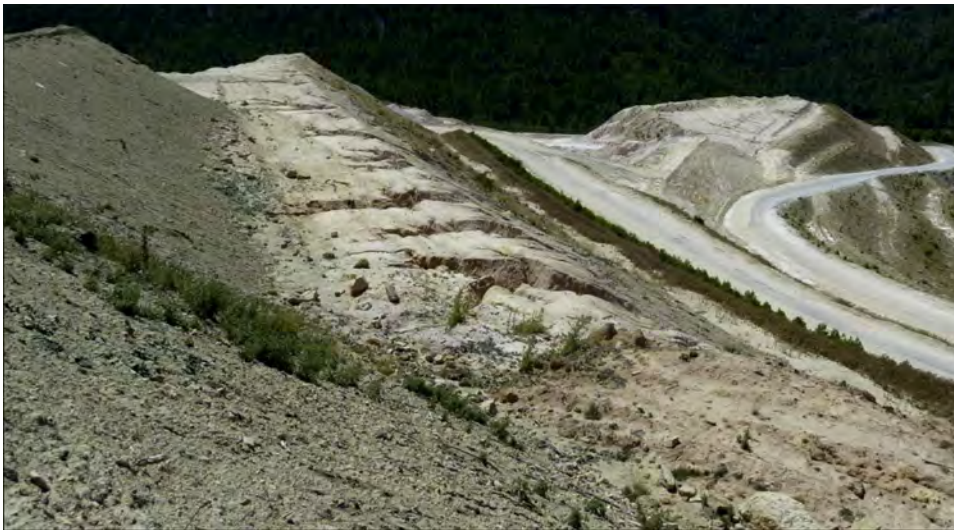
Fig. 17. Inversion of a berm slope by sediment accumulation at the toe of the upper outslope, leading to gullying downstream.

The observed reasons for gully of terrace-constructed landforms of El Machorro are either run-on from hauling roads (Fig. 16) or slope inversion because of sediment accumulation in the internal part of the berm (Fig. 17). Once run-on happens, it discharges concentrated flows from across the terrace bench onto the outslopes and initiates gully. When these effects occur, Caobar immediately proceeds to correct them, but they require very costly interventions.
