Drainage network evolution and reconstruction in an open pit kaolin mine at the edge of the Alto Tajo natural Park

ABSTRACT

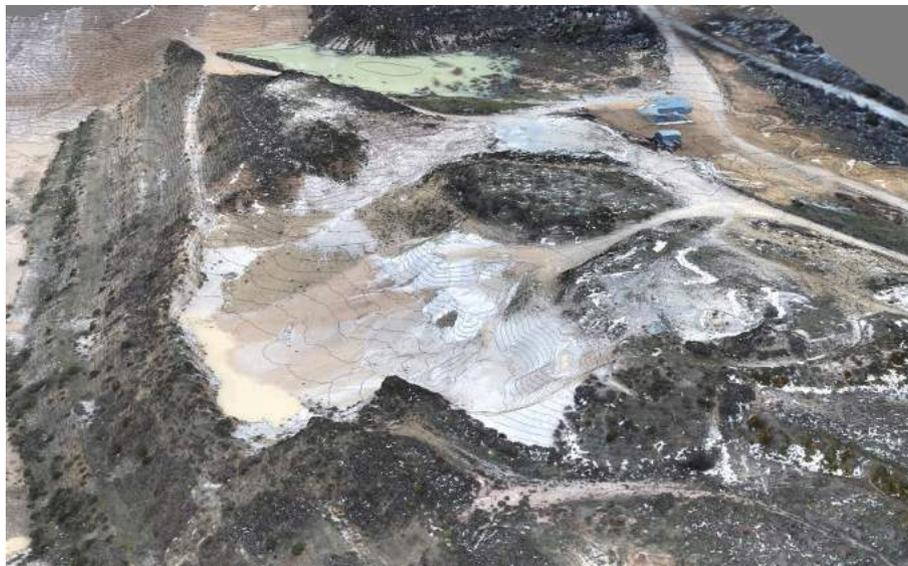
Fig. 7. Tiled model textured and contour view of the topography surveyed with SfM-UAV on 15.04.2018.

A detailed topography was surveyed using the SfM-UAV procedure (Fig. 7) to represent the initial condition of the area. A geomorphic design was generated for the upper part of the non-reclaimed area (Fig. 8) based on that topography and the parameters measured in a local natural analogue. The channels have a zig-zag (slope $> 4\%$) and meander (slope $< 4\%$) shapes; convex-concave hillslopes and concave swales were added to the design. One channel is tributary to another, ending in a pond that operates as base level. The channel slope varies

(0–13%); the entire reclaimed area has an average 22% slope. The external terraces were also designed to be adapted to the surrounding hillslopes (Fig. 7). The original terraces were very steep (50–60%), whereas those designed are gentler (30–45%). Berm width varies in the range 7–13 m, having an 8% inverted gradient. This inverted gradient berm is a key issue for terrace preparation, preventing water flowing from the next slope, thereby triggering rill and gully erosion.

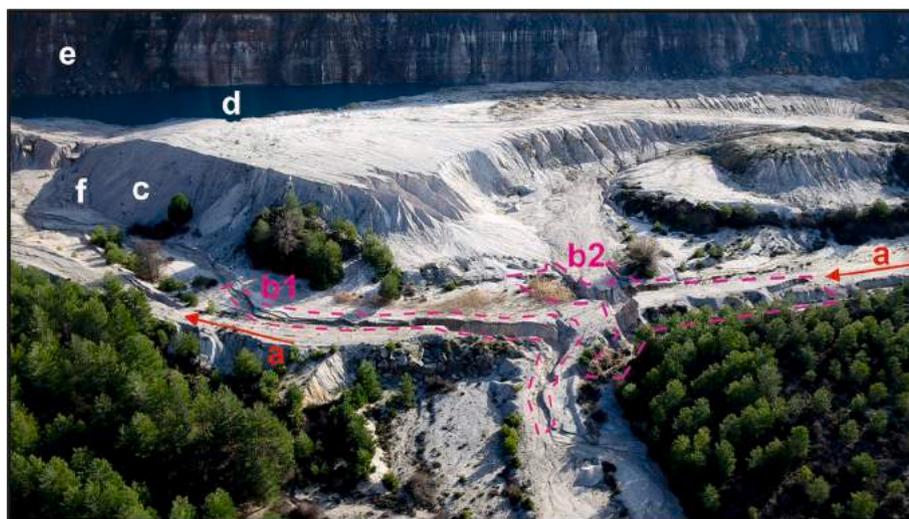
Fig. 9. Oblique photo of the main active gully erosion in the Nuria mine threatening an upstream pond (photographed on 26.03.2020). Road (a); left (b1) and right (b2) headcutting gully erosion; earth—sand—dam (c) enclosing the pond (d); highwall (e); weakest area in the earth—sand—dam (f). Photo by DGDRONE (2020).

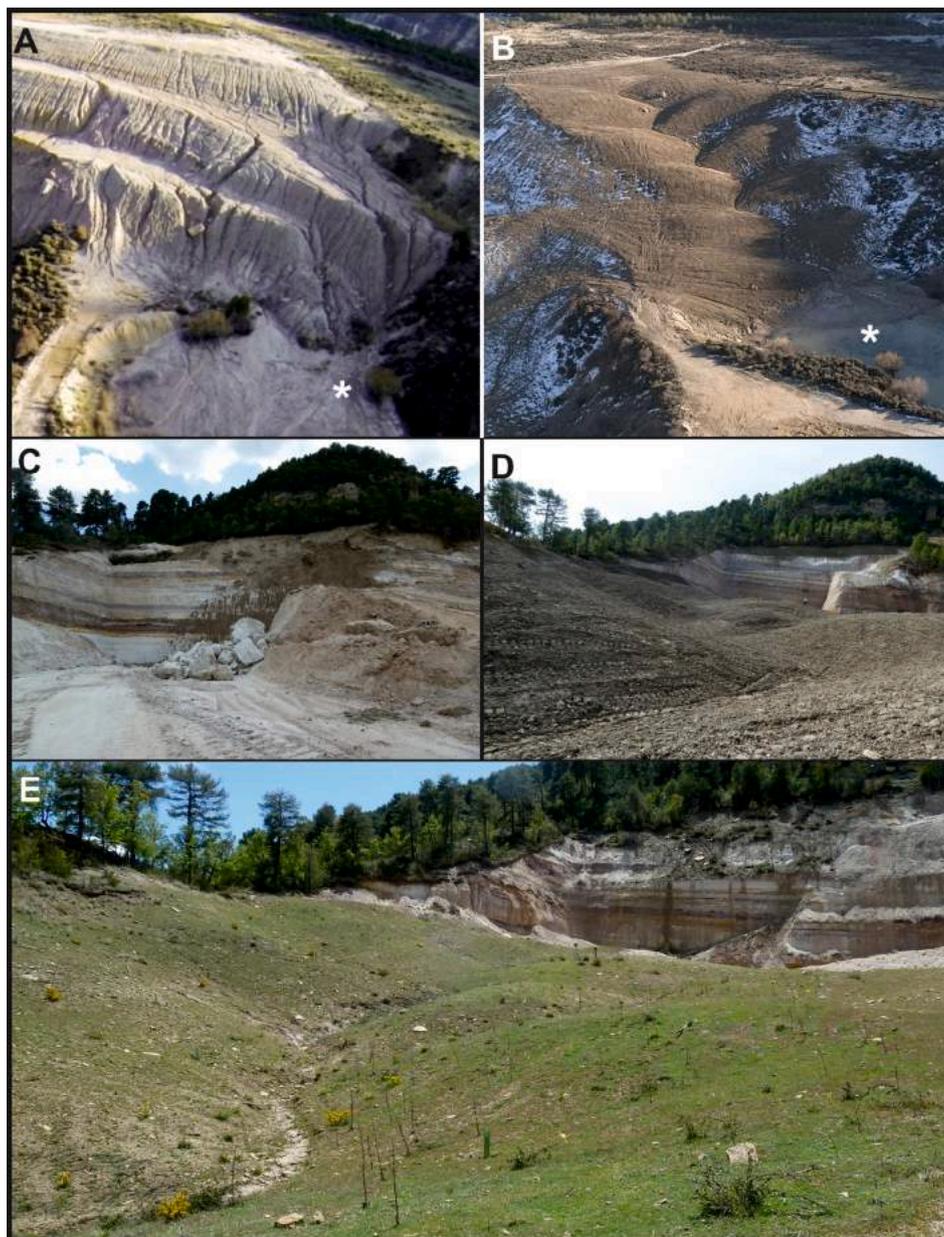
Fig. 10. Other geomorphic rehabilitation surfaces in mines of the Alto Tajo: Nuria (before, A; after, B) and Machorro (before, C; after, D; present, E). (*) pond position is used as reference. A and B oblique photos by DGDRONE.
