International Journal of Mining, Reclamation and Environment

Geomorphic landscape design integrated with progressive mine restoration in clay quarries of Catalonia

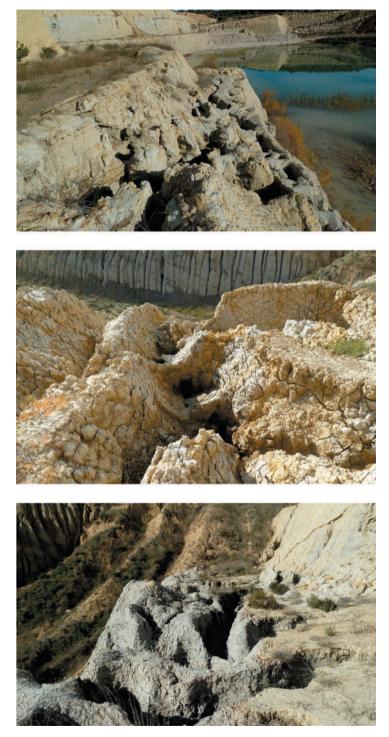
Figure 2. Tunnel erosion, piping, at benches of highwall terraces, at the Pastor I quarry.

Landforms denoting active tunnel erosion processes were identified in the existing highwalls of these clay quarries (Figure 2). Tunnel erosion, or piping, refer to the formation of linear voids, or pipes, by the preferential flow of subsurface water in soils and unconsolidated or poorly consolidated materials [52]. Tunnel erosion processes are complex to understand and their occurrence is strongly related to a number of different soil properties [52,53]. Sodic soils with a certain content of exchangeable sodium behave as dispersive soils and potentially develop tunnel erosion, while other soils with exactly the same exchangeable sodium content will not, due to the interaction between many other soil factors [54]. Analysis of EC (Electro Conductivity) and Exchangeable cation content, with emphasis on the exchangeable sodium percentage (ESP), were performed for the clay substrata and wastes, to assess dispersion potential.

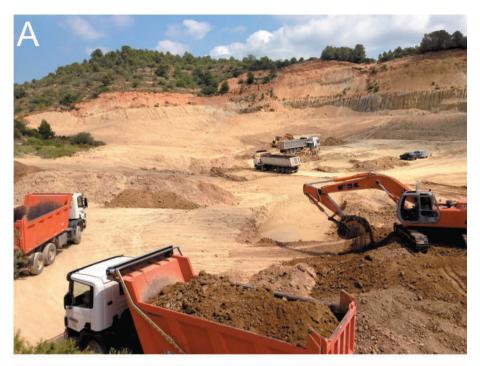
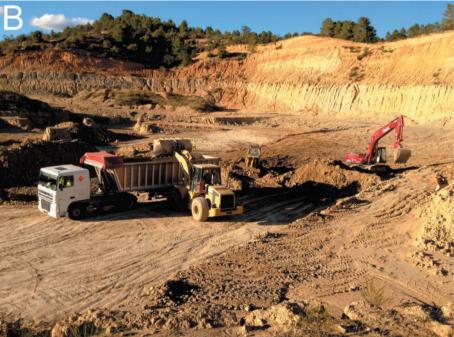
Figure 4. Photos of June 2015 showing the simultaneous process of exploitation and restoration at the Aurora quarry. (a) The two tipper trucks and the excavators, in foreground, are handling topsoil for restoration; the two box trucks and the loader the centre of the image are loading and transporting clay for the cement plant. (b) The loader is loading clay at a box truck (exploitation) whereas the excavator and a bulldozer, to their right, are regrading the final surface according to the geomorphic restoration plan.

At this final stage, exploitation and restoration were simultaneous (Figure 4). The main channel and the lower part of the three tributaries were excavated on the existing platform, so the final exploitation topography in these areas were final restoration landforms. Figure 5 is a time-lapse sequence of several oblique aerial photos of Aurora.

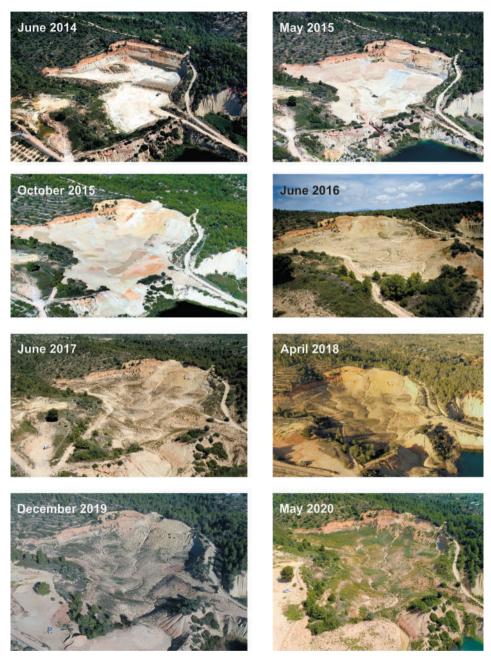
Figure 5. Comparison of oblique aerial photos of the Aurora quarry from June 2014 to May 2020 (photos by Paisajes Españoles and OFTECO).

An analysis of the oblique aerial photos, topographical surveys and field inspections of Aurora showed an adequate landscape recovery. However, minor deviations from the expected results occurred. They were (Figure 6): (a) runoff from vegetation maintenance and watering access roads entered reclamation not designed to accept this runoff, leading to rilling and gullying; and, (b) local piping (tunnel erosion) occurred in specific areas, where the clay waste was not properly covered.

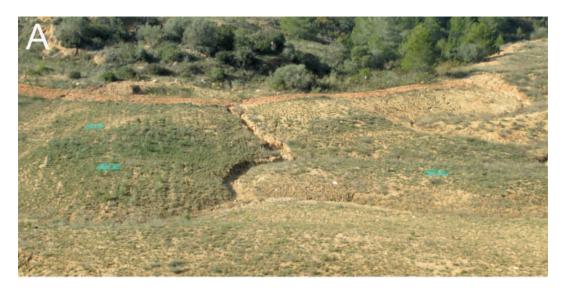
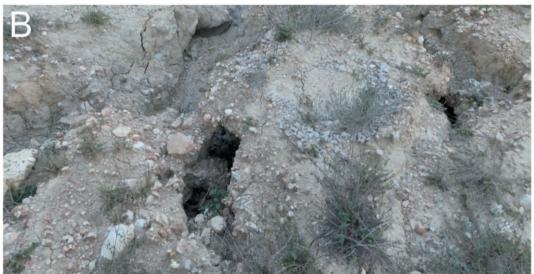
Figure 6. (a) Gully formed from run-on entering from an access road. (b) Tunnel erosion (piping) occurrence related with inappropriate topsoil covering.

Tunnel erosion (piping) occurred in some areas of Aurora where the topsoil was not evenly and carefully spread over some clay wastes. Therefore, despite the results at Table 2 suggest that clay substrata and wastes in the area are not susceptible to present dispersive behaviour regarding sodium content, tunnel erosion is a fact, both at Aurora and near Pastor I (Figure 2). We therefore hypothesise that: (i) there must be other as yet unknown reasons for tunnel erosion, such as the movement of non-cohesive fine particles, but we have no evidences of it; (ii) since ESP test is only one method to assess dispersivity, others (crumb test or double hydrometer) methods may probe the contrary.

- The highest factor of erosional instability has been upslope run-on entering restored areas not designed to accept it. This happened at the highwall area and from access roads for vegetation maintenance and watering, leading to scattered downslope rilling and gullying. Although this is a well-known situation elsewhere [8], here it was clearly confirmed. Therefore, road drainage should be carefully handled in other mine restoration projects.

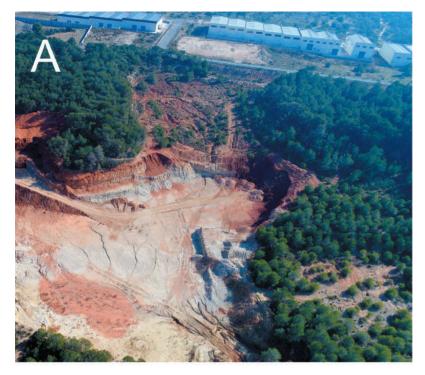
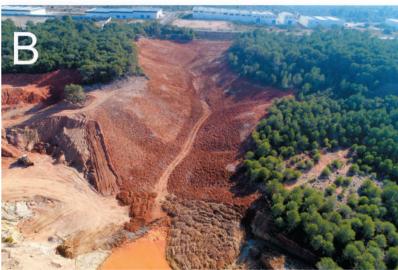
Figure 9. (a) Oblique aerial view of Pastor II – starting point in February 2019. (b) Oblique aerial photo after geomorphic restoration, in January 2020 (both photos by OFTECO). Note the road at the head of the restored watershed for comparison of both photos. Note also that the main channel is not completed yet, which is being used as a road access for revegetation. A detail of its final shape is shown at Figure 11(b).

The building process of the geomorphic design for Pastor II, according to the new geomorphic approach, started in June 2019. By the end of January 2020, Phase 1, one sub-watershed, had been completed (Figure 9). The machinery pool and topographical survey devices used in Pastor II were the same as used at Aurora. Given the recent completion, no monitoring has yet been conducted.

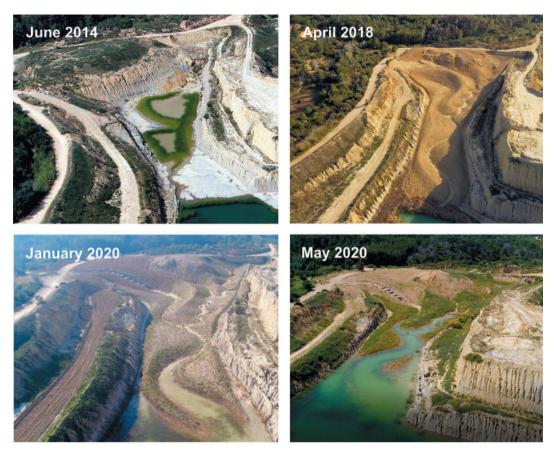
Figure 10. Oblique aerial photos of Pastor I from June 2014, before restoration, end-of-mine state, to May 2020, after restoration (photos by Paisajes Españoles and OFTECO).

The paper focuses on the Aurora and Pastor II cases, since progressive (geomorphic) mine restoration is a main topic here, but a sector of the Pastor I quarry has been also subject to geomorphic-based restoration, in this case at an end-of-mine phase (Figure 10).

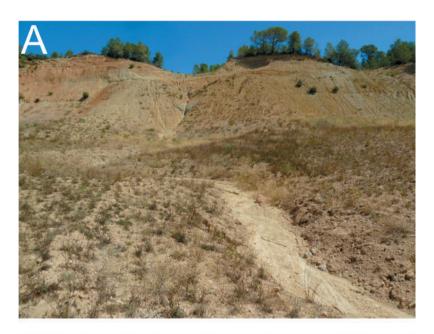
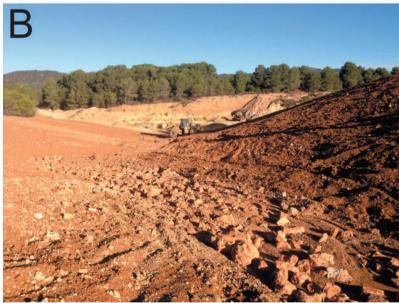
Figure 11. (a) Restored fluvial channel replicating a natural one, at the Aurora restored quarry, after four years of restoration. As it can be seen, the channel is subject to active sediment movement. However, such dynamic is fully integrated in the natural one of this environment, allowing the self-repair of nearby hillslopes. (b) Restored fluvial channel at Pastor II, incorporating extra safety armouring (limestone pebbles and boulders) at the outset.

- The restored fluvial channels of Aurora, which replicated natural drainage according to the Rosgen's classification, experienced a relative high channel dynamics, with significant sediment movement. Without a proper geomorphic understanding of the torrential dynamics of the 'natural' fluvial networks of this Mediterranean region, this fact could be considered a sign of 'instability'. Natural fluvial geomorphic landforms are dynamic systems, not static, and the 'stability' we seek in restoration must honour the local conditions. The observed dynamics of the Aurora fluvial channels attain the advantages and considerations that Sawatsky and Beckstead (see [10]), masterfully gathered for designing and building drainage networks that replicate natural ones. They are: (a) the meandering channels attenuated the inflows by providing flood storage, reducing flow velocities; (b) overtopping was avoided by channels located in swales and at the bottom of valleys; (c) instead of rigid bed and banks (such as of concrete or rip-rap), the designed channels had a natural armour mobile bed to move in response to extreme flood events; (d) these 'natural' replicated channels were able to move vertically in response to changes in the river system; (e) large floods on channel beds washed out their formed armour layers, however, subsequent flows caused bed re-armouring through a resupply of coarse material or by limited degradation of the channel bed. The net result has been the re-establishment of stable local fluvial regimes. Replication of natural channels and systems in Aurora reduced the risk of accelerated erosion and enabled the self-repair of erosion control systems. The observation of the bed re-armouring at Aurora led us to incorporate proper armouring at Pastor II from the beginning (Figure 11) as an extra stability safety measure, once we had visual evidences of worse edaphic conditions at the hillslopes (see reddish colours at Figure 9).
